Inspection Report

| Location of Inspection Glebe Close (ESTGLEC) | Scheduled Time of Inspection 9:26 AM | Inspection Submission Time 8:35 AM |

| 2.1 - Question Please state the name of the block you are inspecting | 2.1 - Responses 1-24 glebe close | |

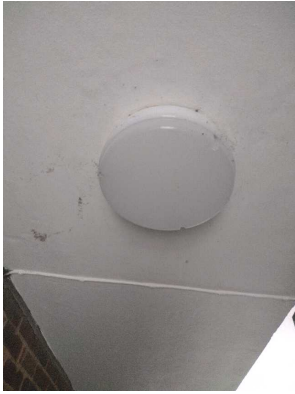
| Q 2.11 - Photo | | |

| 2.11 - Question Are there any Internal Caretaking issues? | 2.11 - Responses Y | 2.11 - Comments 06/05/2025 cob webs required to be cleaned. |

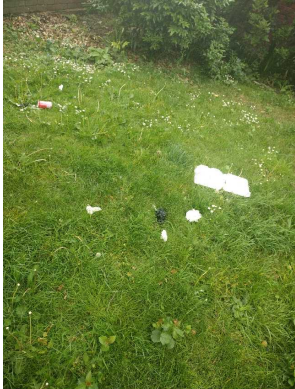
| Q 2.26 - Photo | | |

| 2.26 - Question Are there any External Caretaking issues? | 2.26 - Responses Y | 2.26 - Comments 06/05/2025 litter pick outside front of block. |

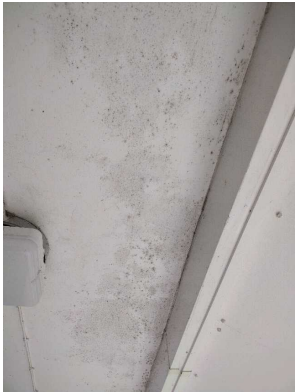
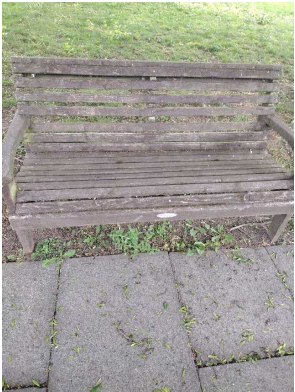
| Q 2.57 - Photo | Q 2.57 - Photo | Q 2.57 - Photo |

| 2.57 - Question Are there Communal Repairs to raise? | 2.57 - Responses Y | 2.57 - Comments 06/05/2025 hanging wires. 2.57 - Comments 06/05/2025 damp visable on Ceiling maybe due to guttering requires a clean 2.57 - Comments 06/05/2025 bench requires a replacement paint and relocated |

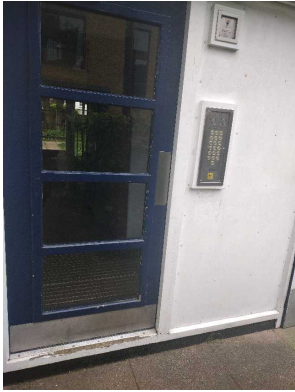
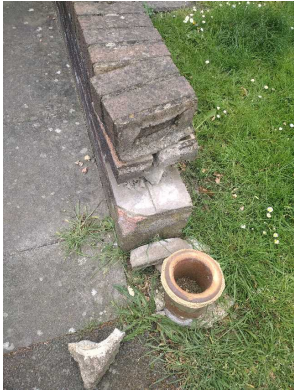
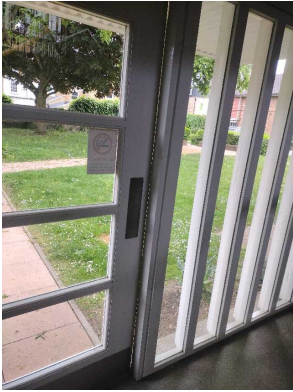
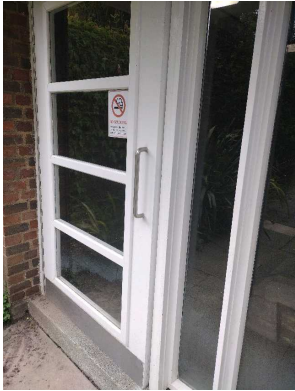
| Q 2.60 - Photo | Q 2.60 - Photo | Q 2.60 - Photo |

| 2.60 - Question Are there any Door Handles and Closures repairs? | 2.60 - Responses Y | 2.60 - Comments 06/05/2025 intercom system not working awaiting for programme plan. John H. 2.60 - Comments 06/05/2025 brick wall broken. 2.60 - Comments |

| | | 06/05/2025 back door of block 13-18 not closing. 2.60 - Comments 06/05/2025 back door of last block by 24. |

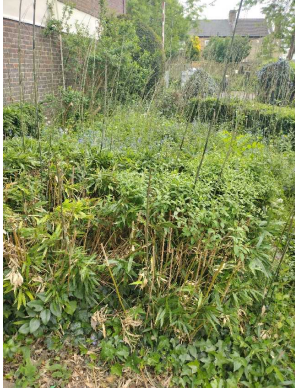
| 3 Block 2 | | |
|--|--|--|
| Q 3.7 - Photo | | |

| 3 Block 2 | | |
|--|--|--|
| 3.7 - Question Are there Flower/Shrub Areas issues? | 3.7 - Responses Y | 3.7 - Comments 06/05/2025 requires a cut back. |

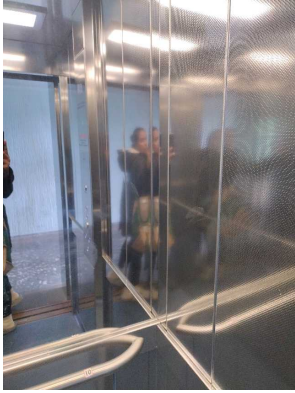
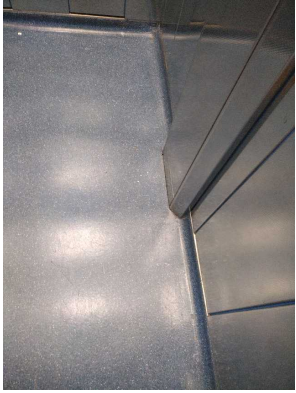
| Q 3.11 - Photo | Q 3.11 - Photo | |

| 3.11 - Question Are there any Internal Caretaking issues? | 3.11 - Responses Y | 3.11 - Comments 06/05/2025 lift requires a clean |

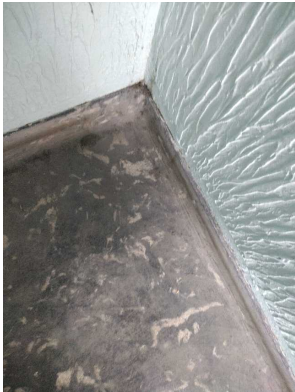
| Q 3.12 - Photo | | |

| 3.12 - Question Are there any Cleanliness: Stairs issues? | 3.12 - Responses Y | 3.12 - Comments 06/05/2025 dust and debris visible on stairs and landing. |

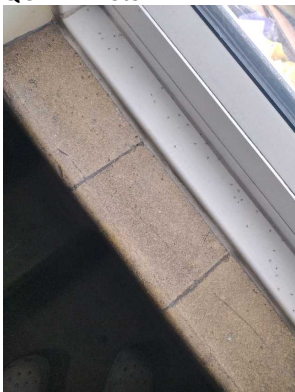
| 5 Block 4 | | |
|--|---|--|
| Q 5.17 - Photo | | |

| 5 Block 4 | | |
|--|---|--|
| 5.17 - Question Are there any Ledges issues? | 5.17 - Responses Y | 5.17 - Comments 06/05/2025 ledges dusty. |
